**Flood Control Project Maintenance
Levee Inspections
LMA District Cover Sheet
Spring 2010 Levee Inspection Results**

Reclamation District No. 0784 Plumas Lake

Levee Inspection Report By Mile - Spring 2010

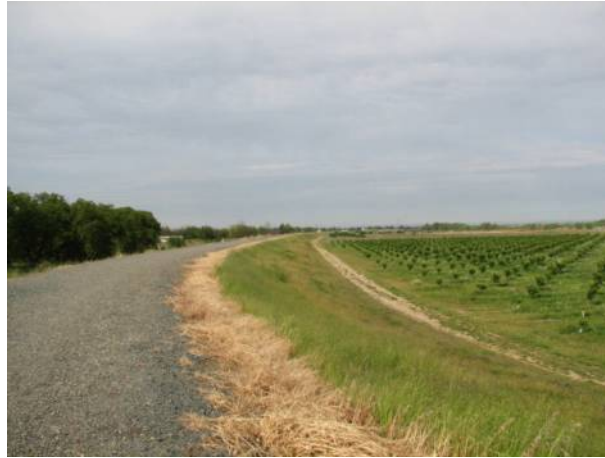
cathom_s_20100520_070.jpg

Levee Mile Report Line	1
Start Levee Mile	0.04
End Levee Mile	2.21
Location	Water Side
Category	Earthen Levee
Item	Vegetation

Water side vegetation levee mile 0.00.

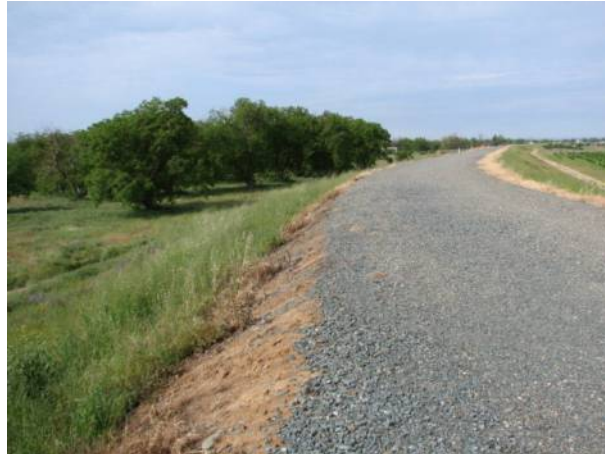
cathom_s_20100520_069.jpg

Levee Mile Report Line	2
Start Levee Mile	0.04
End Levee Mile	2.21
Location	Land Side
Category	Earthen Levee
Item	Vegetation

Land side vegetation levee mile 0.00.

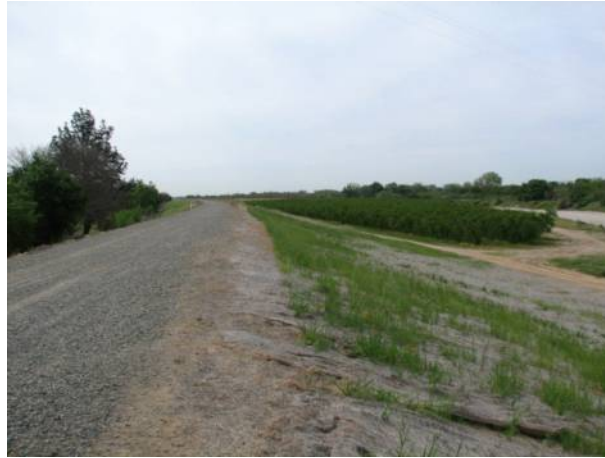
cathom_s_20100520_072.jpg

Levee Mile Report Line	1
Start Levee Mile	0.01
End Levee Mile	12.78
Location	Water Side
Category	Earthen Levee
Item	Vegetation

Water side vegetation levee mile 0.00.

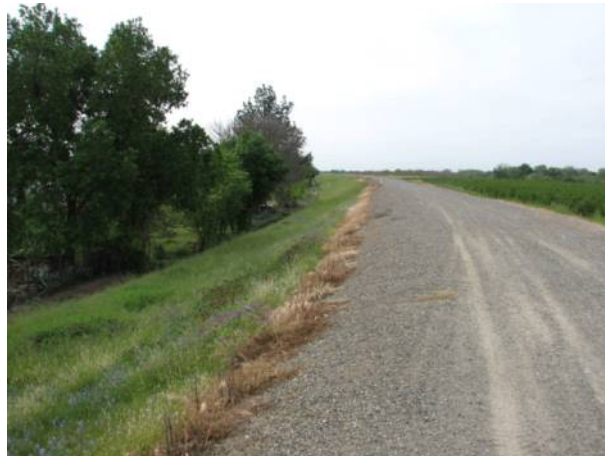
cathom_s_20100520_071.jpg

Levee Mile Report Line	2
Start Levee Mile	0.01
End Levee Mile	12.78
Location	Land Side
Category	Earthen Levee
Item	Vegetation

Land side vegetation levee mile 0.00.

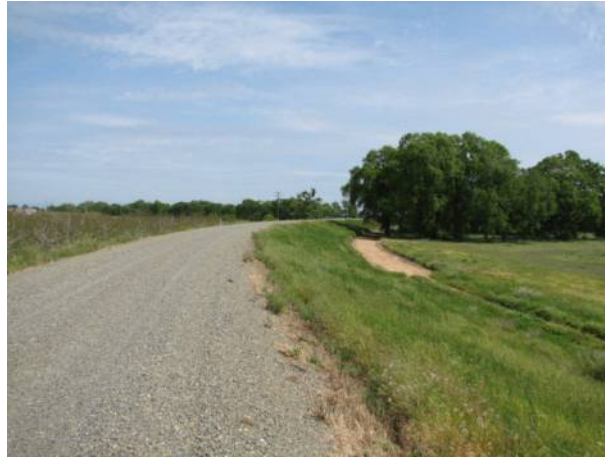
cathom_s_20100520_076.jpg

Levee Mile Report Line	1
Start Levee Mile	2.44
End Levee Mile	3.20
Location	Water Side
Category	Earthen Levee
Item	Vegetation

Water side vegetation levee mile 2.44.

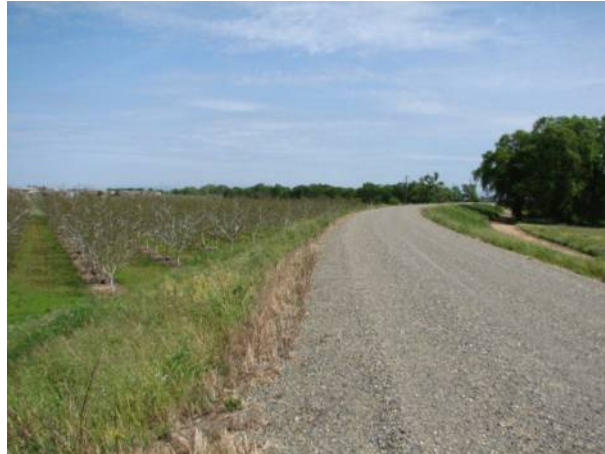
cathom_s_20100520_075.jpg

Levee Mile Report Line	2
Start Levee Mile	2.44
End Levee Mile	3.20
Location	Land Side
Category	Earthen Levee
Item	Vegetation

Land side vegetation levee mile 2.44.

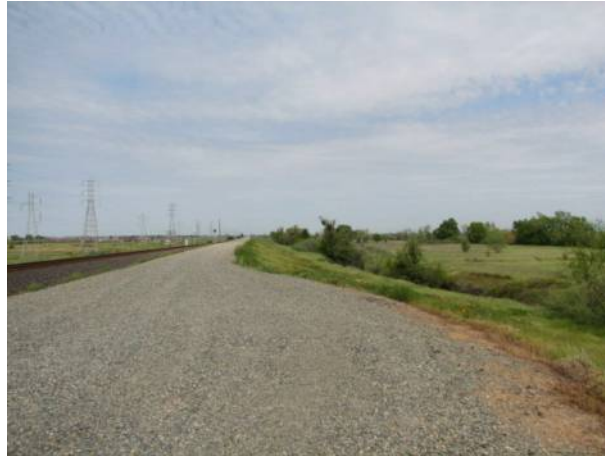
Levee Mile Report Line	1
Start Levee Mile	0.00
End Levee Mile	5.86
Location	Water Side
Category	Earthen Levee
Item	Vegetation
Water side vegetation levee mile 0.00.	
cathom_s_20100520_077.jpg

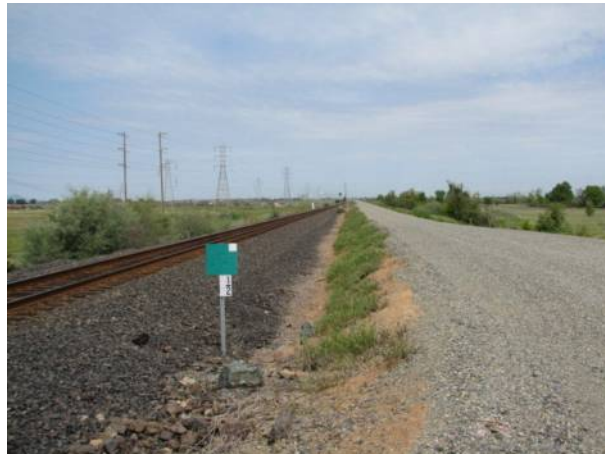
Levee Mile Report Line	2
Start Levee Mile	0.00
End Levee Mile	5.86
Location	Land Side
Category	Earthen Levee
Item	Vegetation
Land side vegetation levee mile 0.00.	
cathom_s_20100520_078.jpg

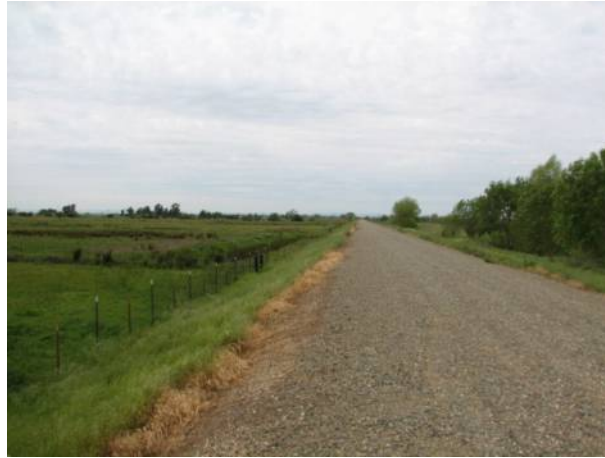
cathom_s_20100520_079.jpg

Levee Mile Report Line	1
Start Levee Mile	0.00
End Levee Mile	3.87
Location	Land Side
Category	Earthen Levee
Item	Vegetation

Land side vegetation levee mile 3.87.

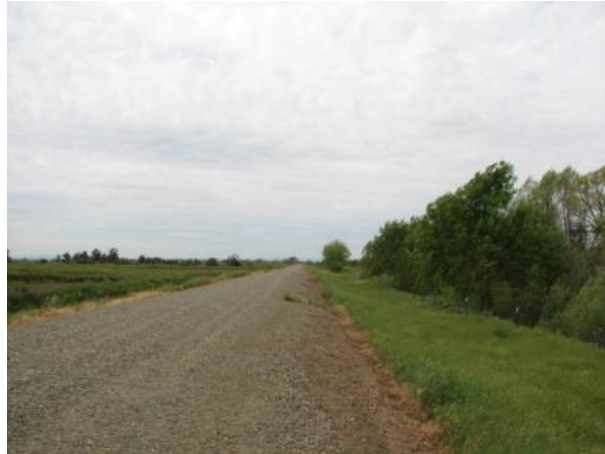
cathom_s_20100520_080.jpg

Levee Mile Report Line	2
Start Levee Mile	0.00
End Levee Mile	3.87
Location	Water Side
Category	Earthen Levee
Item	Vegetation

Water side vegetation levee mile 3.87.

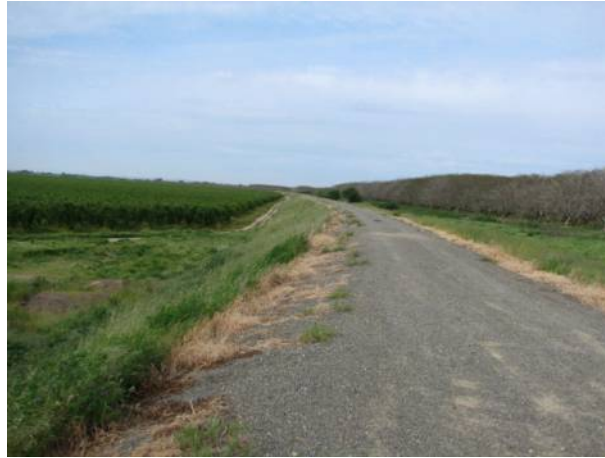
cathom_s_20100520_065.jpg

Land side vegetation levee mile 3.91.

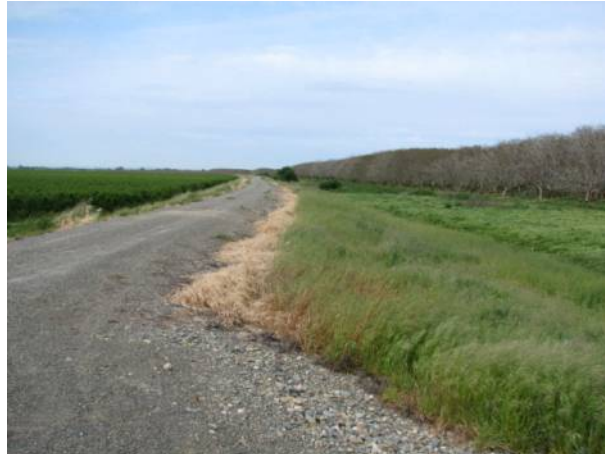
cathom_s_20100520_066.jpg

Levee Mile Report Line	2
Start Levee Mile	0.02
End Levee Mile	3.90
Location	Water Side
Category	Earthen Levee
Item	Vegetation

Water side vegetation levee mile 3.91.

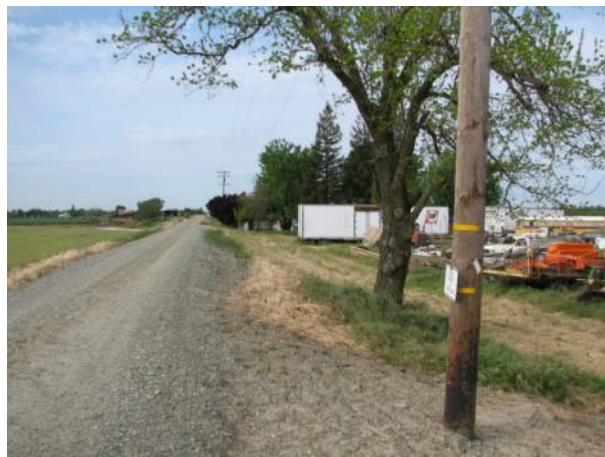
cathom_s_20100520_067.jpg

Levee Mile Report Line	3
Start Levee Mile	2.18
End Levee Mile	2.18
Location	Water Side
Category	Earthen Levee
Item	Encroachments

Water side buildings and equipment levee mile 2.18.

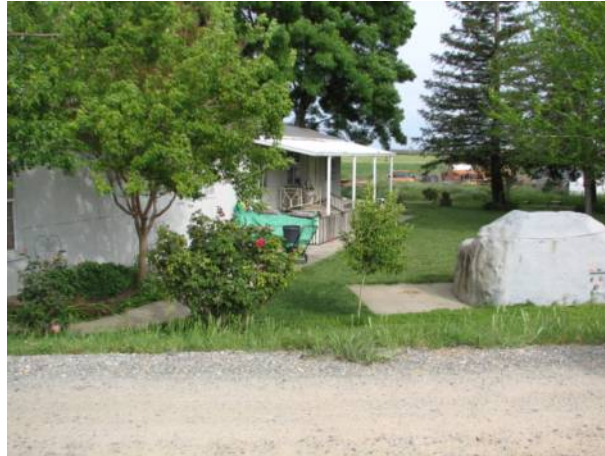
Levee Mile Report Line	3
Start Levee Mile	2.18
End Levee Mile	2.18
Location	Water Side
Category	Earthen Levee
Item	Encroachments
Water side buildings and equipment levee mile 2.18.	
cathom_s_20100520_068.jpg

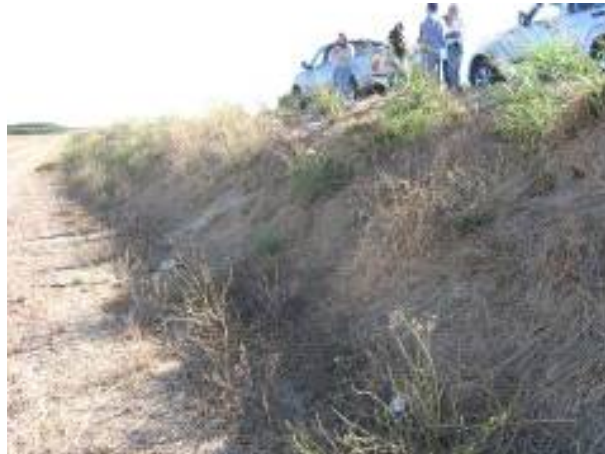
Levee Mile Report Line	4
Start Levee Mile	2.28
End Levee Mile	2.58
Location	Water Side
Category	Supplemental
Item	USACE Erosion Survey
2009: no berm, 1:1 slope, seepage, sands and silts, 0 ft/s [2009 SiteID:YUB_2-3_L]	
USACE2009_YUB_2-3_L_2009_09_19-D5P3_small.JPG

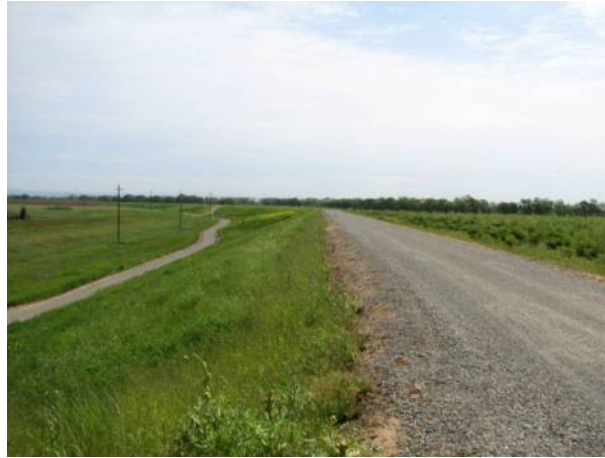
cathom_s_20100520_073.jpg

Land side vegetation levee mile 0.00.

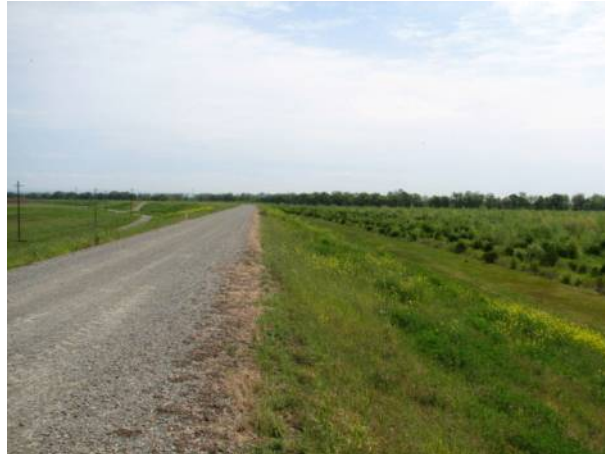
cathom_s_20100520_074.jpg

Levee Mile Report Line	2
Start Levee Mile	0.04
End Levee Mile	1.88
Location	Water Side
Category	Earthen Levee
Item	Vegetation

Water side vegetation levee mile 0.00.
